NINEWA VILLAGE ROADS
SEGMENT 3
GOVERNORATE OF
NINEWA, IRAQ

SIGIR PA-06-035
APRIL 5, 2006

SUBJECT: Report on Project Assessment of Segment 3 of the Ninewa Village Roads in
the Governorate of Ninewa, Iraq (Report Number SIGIR-PA-06-035)

Ninewa Village Roads – Segment 3 Governorate of Ninewa, Iraq

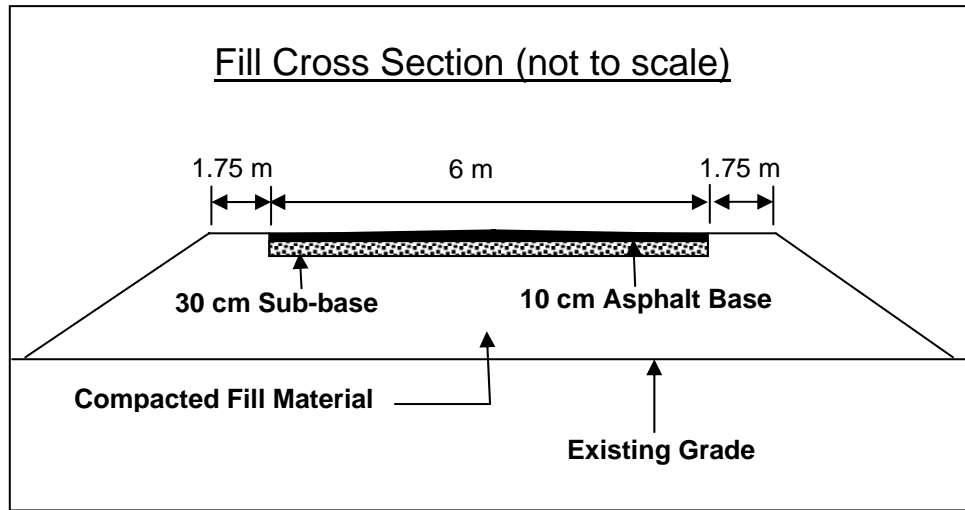
Diagram 1. Typical fill cross section

The contract BOQ included requirements for earthwork cut and fill sections. For fill sections, the contractor was required to clear and grub the natural ground to a depth of 10 cm and provide new suitable fill material compacted in layers of 20 cm to reach the profile contained in typical design cross section. For an illustration of a typical fill cross section, see Diagram 1.

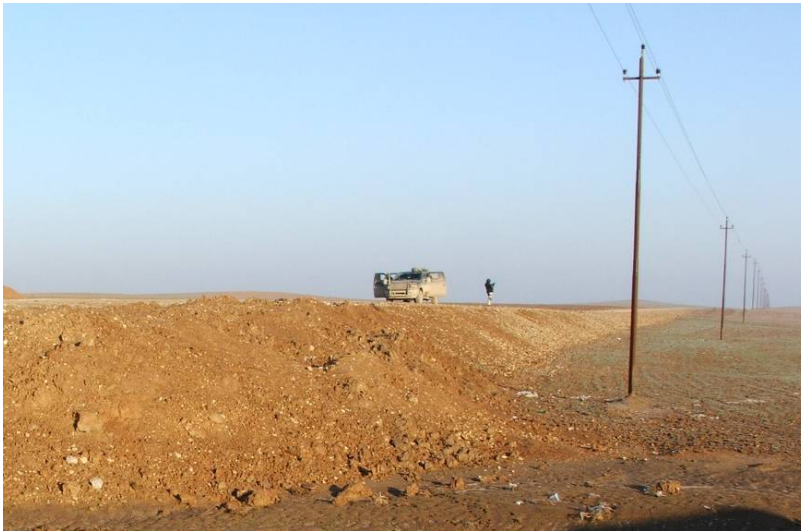
Site Photo 2. Fill section north of Nimrud

Site Photo 2 shows a fill section constructed between the Villages of Balawat and Nimrud.

Based on the review of the contract and our observations on site, the cut and fill sections appeared to meet the requirements of the contract.

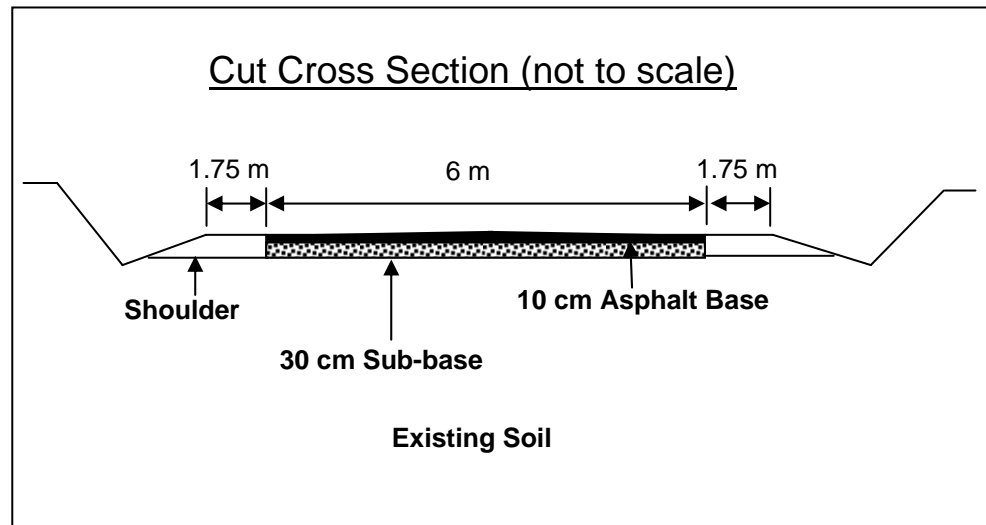
Diagram 2. Typical cut cross section

On a cut section, unneeded materials are removed so as to match the elevations provided in the design profile. Diagram 2 provides an illustration of a typical cut section.

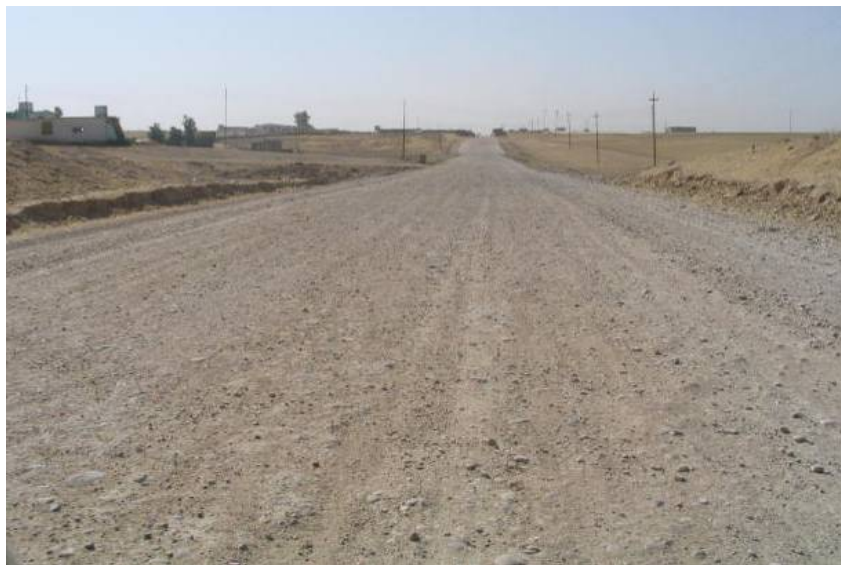
Site Photo 3. Cut section near Balawat – Photo provided by USACE

Site Photo 3 shows a cut section with the sub-base constructed, prior to paving and shoulder construction.

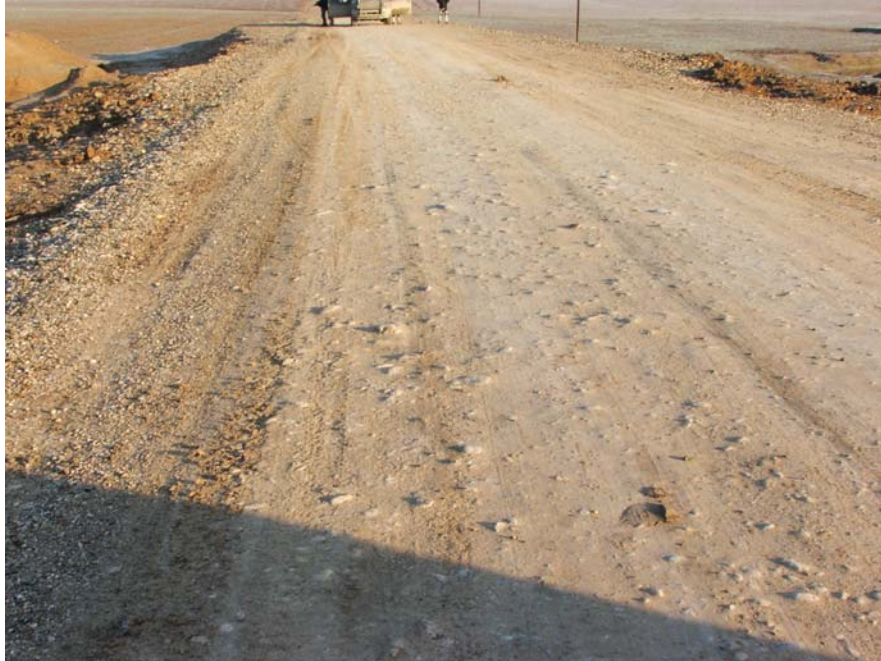
Site Photo 4. Compacted sub-base south of the village of Balawat

The contract bill of quantities and typical cross section drawings required the contractor to spread the sub-base layer with a thickness of 30 cm and a width of 6.5 m in accordance with Section R6 of the Standard Specifications for Roads and Bridges, and direction from the Resident Engineer. The USACE-GRN QA Report dated 03 August 2005, showed the sub-base as 100% complete. Our assessment

confirmed the completion of the sub-base. However, since only 6 km of the 16 km roadway sub-base had been paved at the time of our assessment, the sub-base on the remaining 10 km section shown in Site Photo 4, had deteriorated and will require some rework before further paving begins.

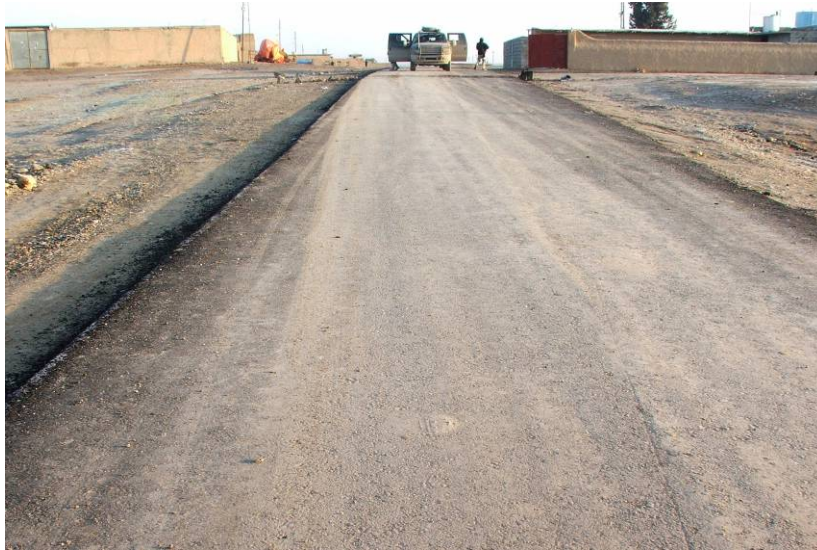
Site Photo 5. Asphalt concrete pavement near village of Balawat

Inspection of the paved sections did not reveal any noticeable surface defects such as raveling, bleeding of asphalt, cracking, or potholes (Site Photo 5). The pavement appeared to be smooth, and ride quality of the pavement was good based on the assessment team's observations.

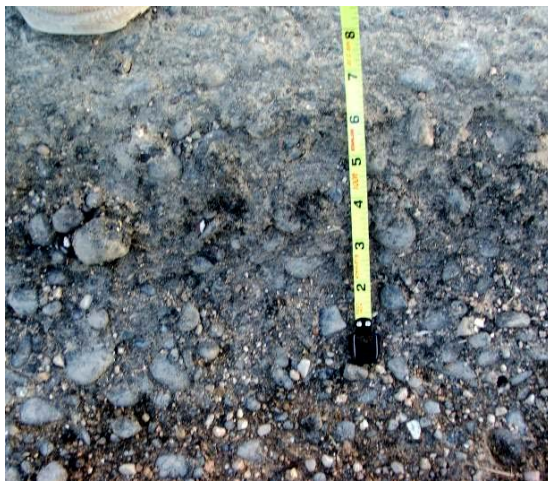
Site Photo 6. Depth of the asphalt base course

The paved areas met the width and thickness requirements of the contract. Site Photos 6 shows the typical asphalt concrete thickness of approximately 10 cm along the length of the paved sections of the roadway.

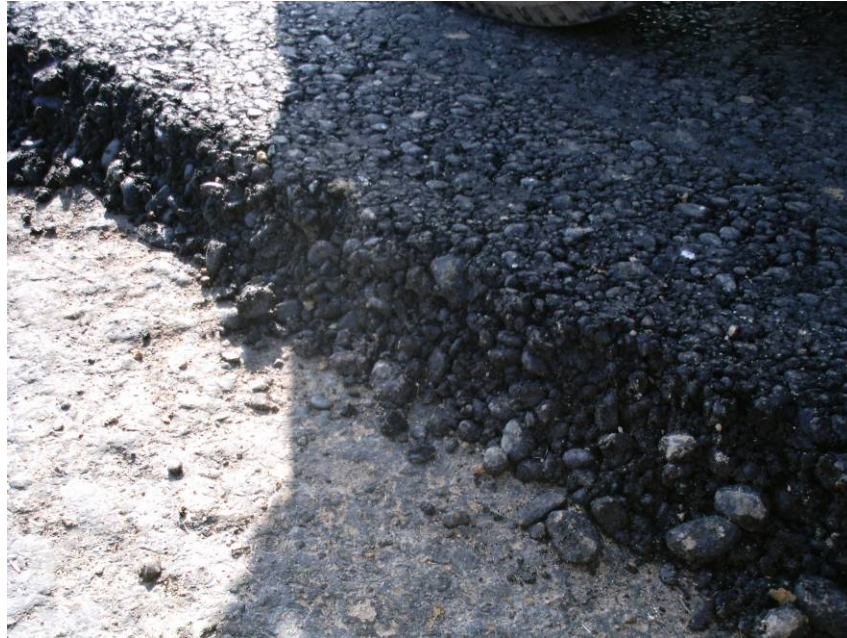
Site Photo 8. Uncrushed gravel used in the asphalt mix (USACE photo taken 18 Dec 05)

Section R9 of the Standard Specifications for Roads and Bridges requires the aggregate used in the asphalt mix to be crushed stone or crushed gravel. The aggregate used in the mix was rounded and intact, presumed to be uncrushed gravel. For a picture of the gravel used in the pavement, see Site Photo 8. It should be noted that the use of uncrushed gravel in asphalt concrete is standard construction practice in Iraq. This was confirmed through discussions with the Resident Engineer and the assessment team's personal observations of other roadway surfaces.

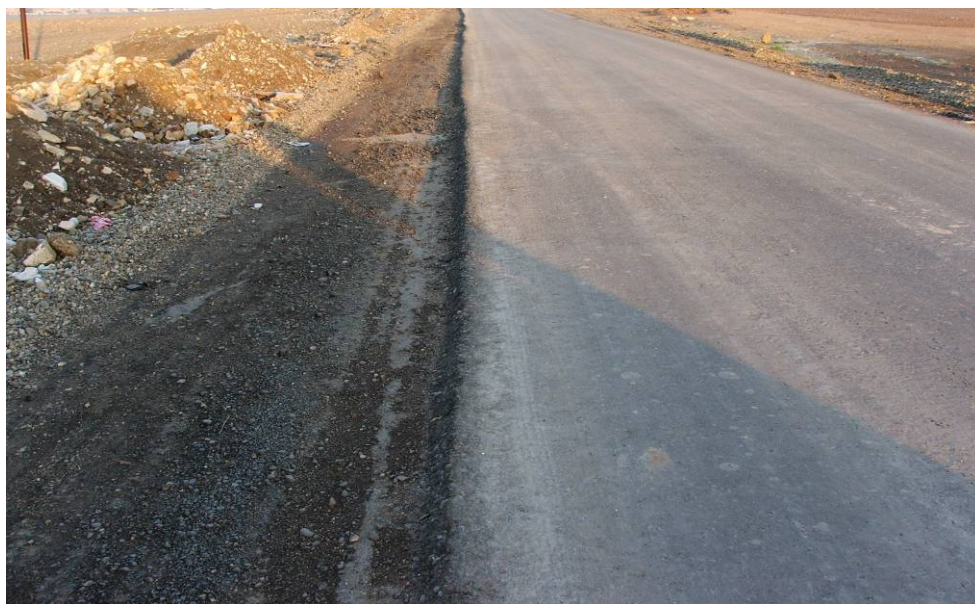
Site Photo 9. Compacted shoulder sub-base

The contract required 1.75 m compacted soil shoulders in each direction. The shoulders had not been completed. We observed in some areas of the paved portion roadway, the contractor had leveled and graded the shoulder sub-base layer, but still needed to add material and compact it to bring the shoulder up to finish grade. Site Photo 9 shows the compacted sub-base for the shoulder adjacent to the pavement. In other areas, the shoulder needed to be re-graded to meet contract requirements.

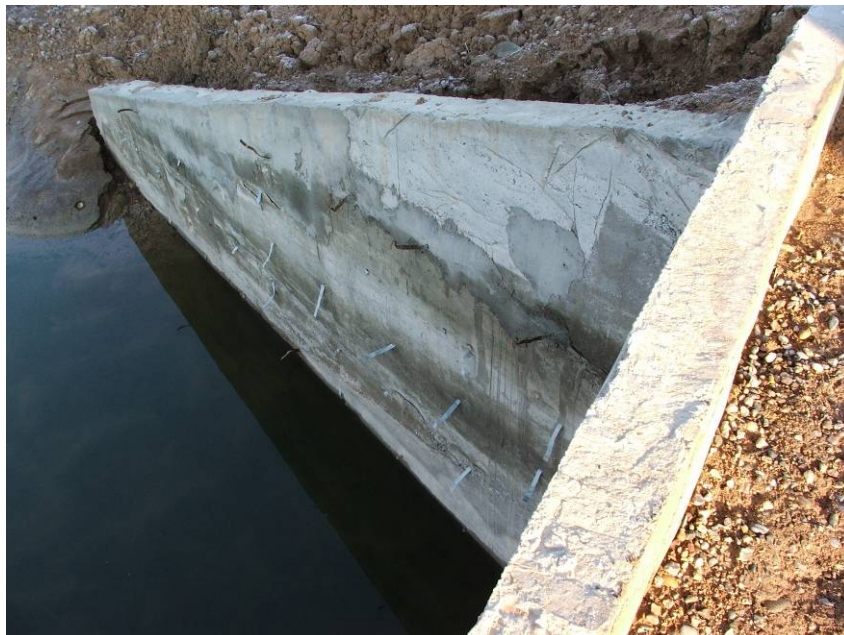
Site Photo 11: Box culvert wing wall

In addition to the box culvert we inspected, a second box culvert was elongated as part of this construction project. We were not able to inspect the second box culvert, although photographs in the USACE QA files show the extension constructed similarly to the culvert shown in Site Photo 10. In addition, although the 3 August 2005 QA report noted completion of the two box culverts, there was no documentation to address the quality of construction or whether the culverts met the requirements of the contract.
